Inspection Report

Building Thermography

Rapid Bloc: Block on block compare to Modular

Date : 2025-03-03

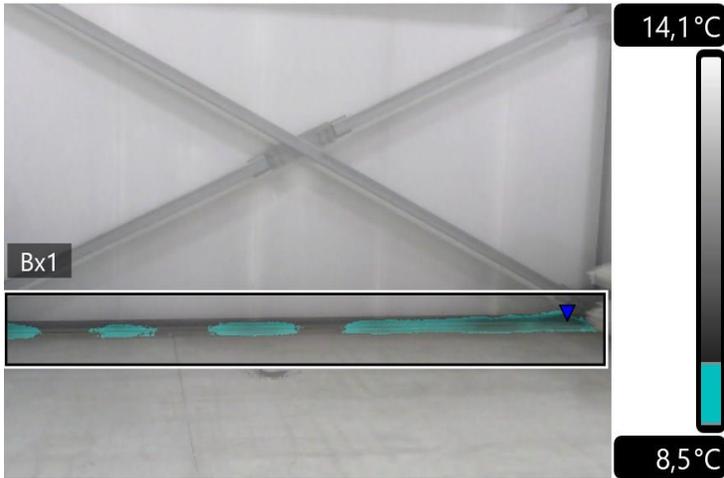
Bx1 Average	10,7 °C
Bx1 Maximum	12,1 °C
Bx1 Minimum	8,2 °C

Air infiltration and insulation loss under the junction of the façade panel wall to the slab/foundation. These air infiltrations and thermal bridges are present almost along the entire length of the façades in this configuration. This cools the floor in front of the junction and should reduce the overall energy efficiency of the building.

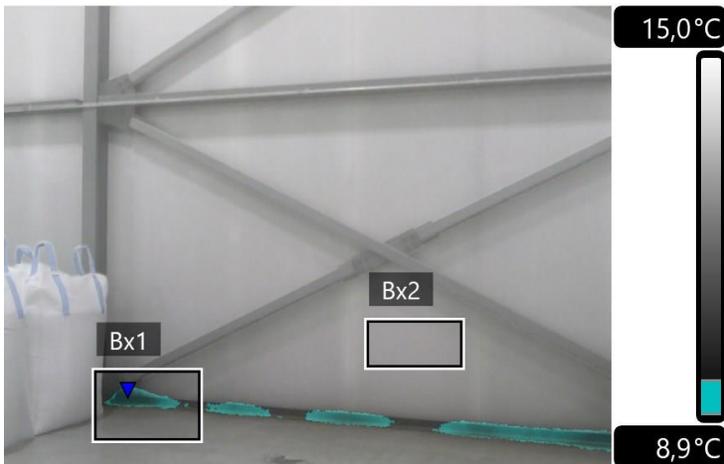
Bx1 Minimum	8,3 °C
Bx2 Average	12,4 °C

Air infiltration and insulation loss under the junction of the façade panel wall to the slab/foundation. These air infiltrations and thermal bridges are present almost along the entire length of the façades in this configuration. This cools the floor in front of the junction and should reduce the overall energy efficiency of the building.

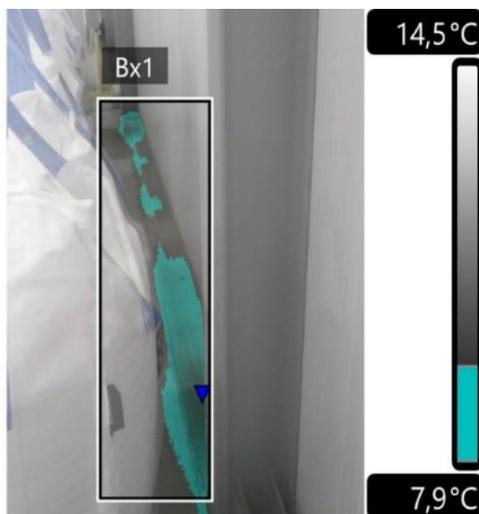
Bx1 Maximum	14,0 °C
Bx1 Average	10,9 °C
Bx1 Minimum	7,4 °C

Air infiltration and insulation loss under the junction of the façade panel wall to the slab/foundation. These air infiltrations and thermal bridges are present almost along the entire length of the façades in this configuration. This cools the floor in front of the junction and should reduce the overall energy efficiency of the building.

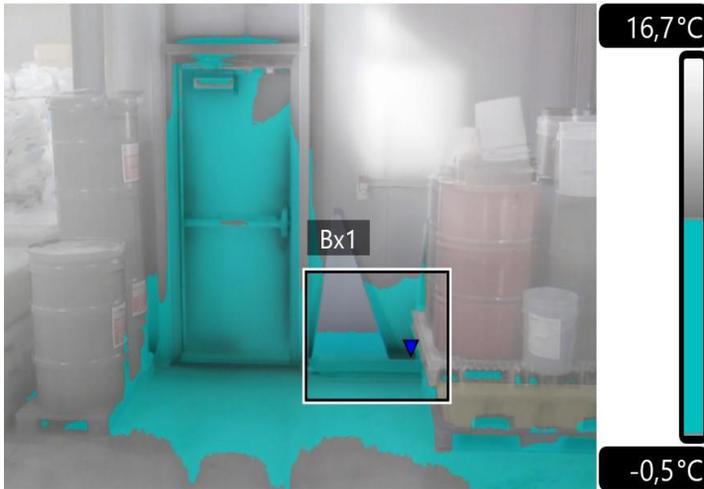
Bx1 Average	8,3 °C
Bx1 Maximum	11,9 °C
Bx1 Minimum	-7,7 °C

Significant air infiltration around door frames. Cold air appears to be infiltrating at high volumes around the frame and in front of the door. It is possible that the problem originates from the door and not the facade cladding, but air infiltration was less severe in the block buildings inspected.

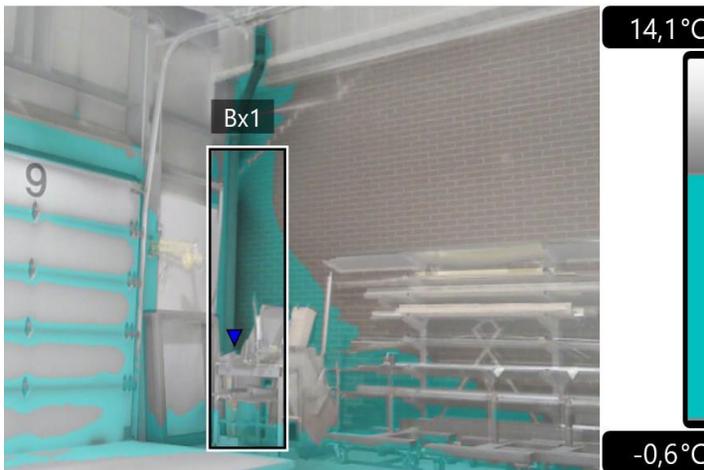
Bx1 Average	7,8 °C
Bx1 Maximum	14,1 °C
Bx1 Minimum	-4,4 °C

The junction between the brick wall and the prefabricated panels is not perfectly sealed or sufficiently insulated. You can see significant air infiltration throughout the brick wall coming from the corner of the junction between the two facades.

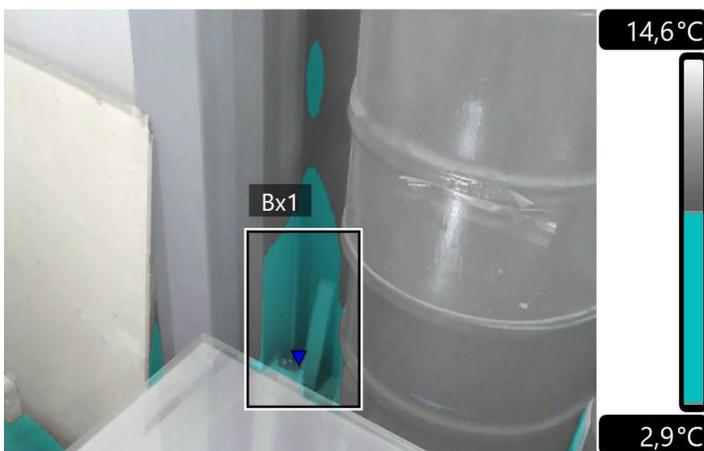
Bx1 Average	8,7 °C
Bx1 Maximum	13,2 °C
Bx1 Minimum	-1,1 °C

Loss of insulation and/or air infiltration to the right of an interior corner of the facades. This is the corner to the left of the door shown in the first photo on this page.

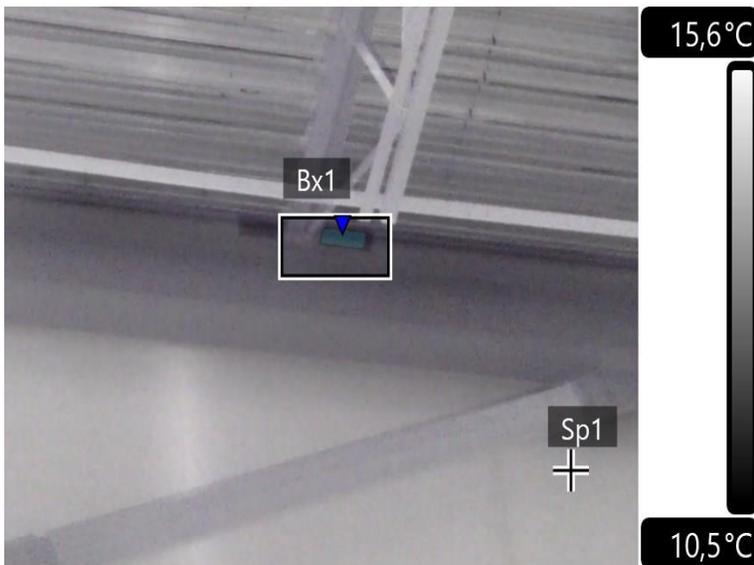
Sp1	13,6 °C
Bx1 Average	11,3 °C
Bx1 Maximum	15,0 °C
Bx1 Minimum	7,3 °C

There appeared to be a loss of insulation at the junction between the roof and the facade.

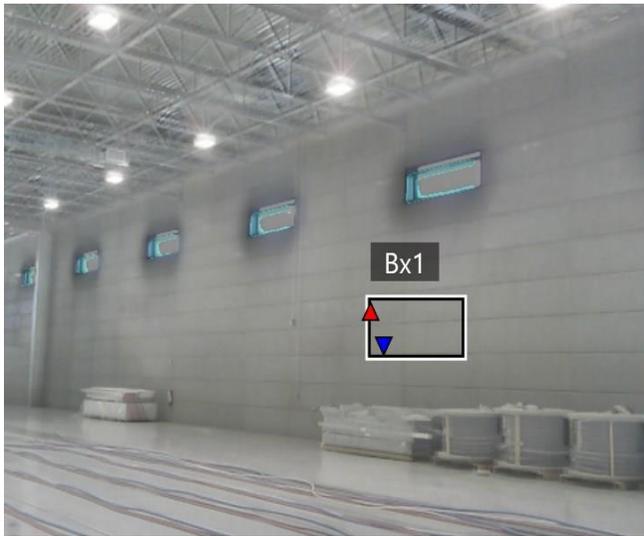
Bx1 Average	18,3 °C
Bx1 Maximum	18,5 °C
Bx1 Minimum	18,0 °C

We can see that the average surface temperature of the block wall is higher than the other 2 construction methods illustrated previously. The insulation R-value of the blocks appears to be higher than both panels and conventional walls.

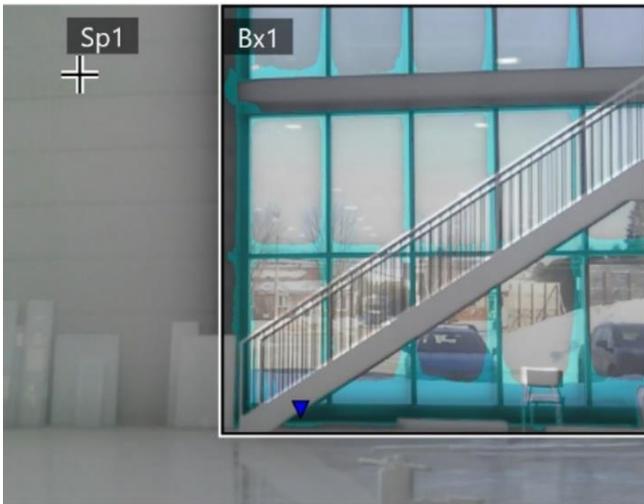
Sp1	18,4 °C
Bx1 Average	12,7 °C
Bx1 Maximum	18,5 °C
Bx1 Minimum	0,4 °C

The only thermal bridges detected are those of the window frames, which is fairly standard since the frame is made of metal and therefore conducts the outside temperature, but the thermal bridge does not seem to pass through the blocks which keeps air infiltration and heat loss to a minimum.

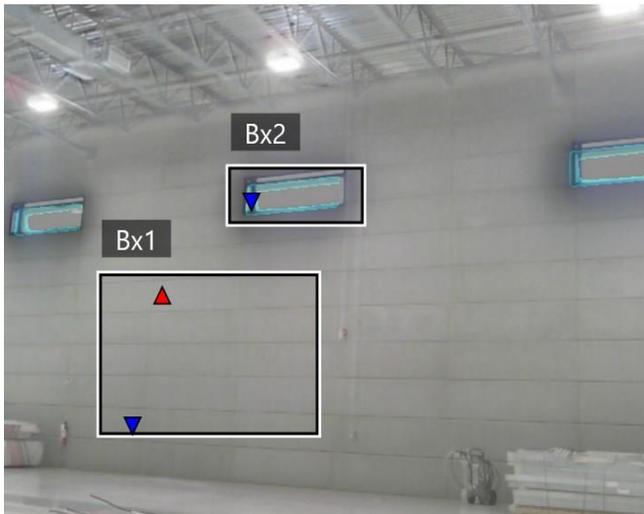
Bx1 Average	18,1 °C
Bx1 Maximum	18,5 °C
Bx1 Minimum	17,3 °C
Bx2 Minimum	3,2 °C

Once again, we can see the temperature of the window frame being cold, but it does not spread into the concrete cladding as much as it does in conventional cladding. The block wall does not appear to be experiencing any insulation loss or air infiltration.

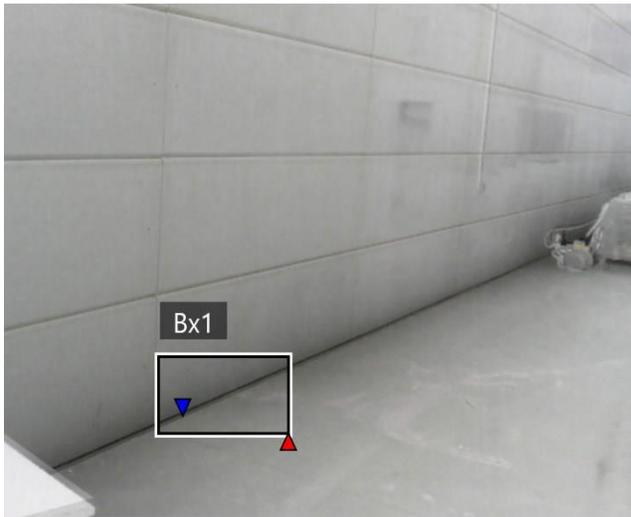
Bx1 Average	16,5 °C
Bx1 Maximum	17,2 °C
Bx1 Minimum	15,4 °C

The bottom of the blocks does not present any heat loss or air infiltration since there is another row of blocks below it which acts as the foundation of the building. The fact that these are blocks stacked up to the ground limits heat loss and air infiltration which seems to greatly improve the airtightness of the facade and the energy efficiency of the building.

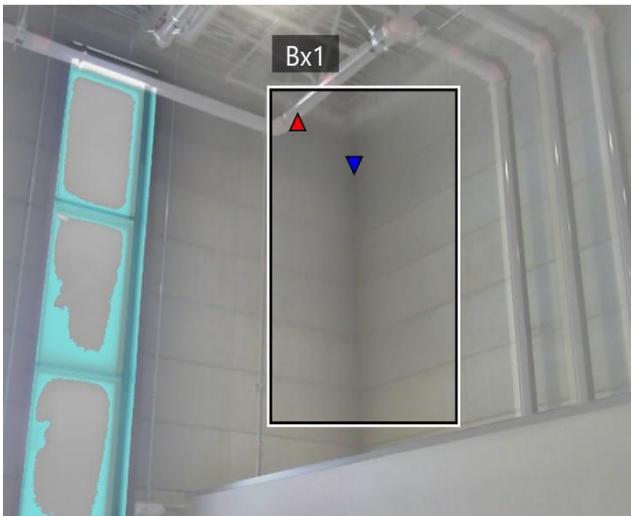
Bx1 Average	17,4 °C
Bx1 Maximum	19,3 °C
Bx1 Minimum	15,9 °C

We can see that the temperature of the corner is quite warm and the corner/junction between the 2 facades does not seem to present any thermal losses and/or sealing losses.

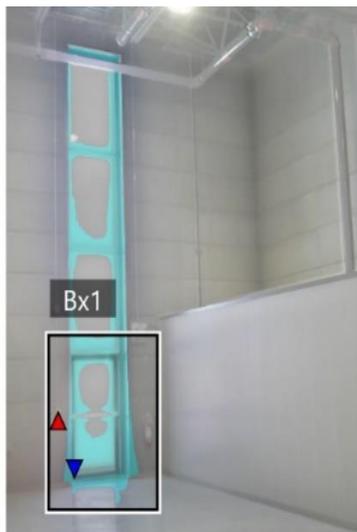
Bx1 Average	10,7 °C
Bx1 Maximum	16,9 °C
Bx1 Minimum	-8,5 °C

Air infiltration around the door frame is limited to the front of the door. It appears to be less significant when the cladding is constructed of blocks on blocks, unlike other construction methods.

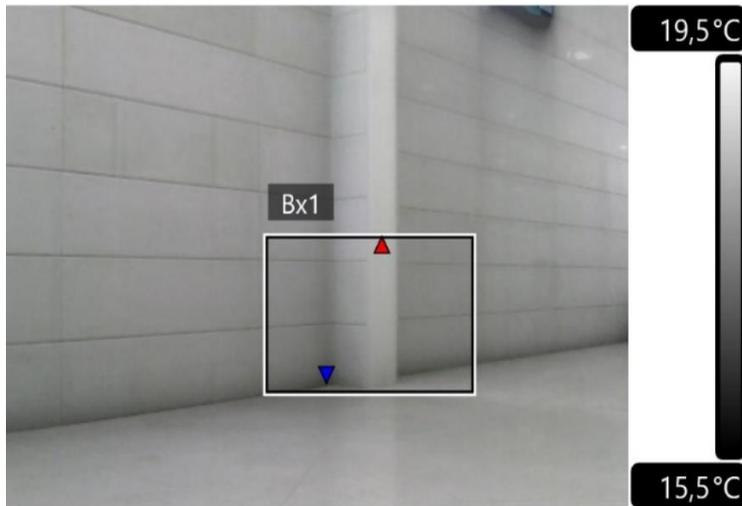
Bx1 Average	17,3 °C
Bx1 Maximum	18,9 °C
Bx1 Minimum	15,4 °C

As before, we can see that there is no air infiltration and thermal losses at the bottom of the blocks and even between the junctions of the intersecting blocks.

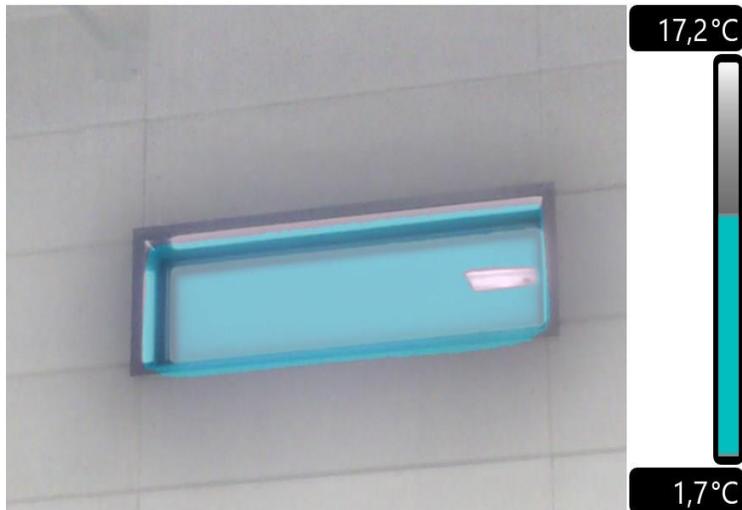
We used a lens with a higher zoom to analyze the thermal bridge / possible air infiltration around the windows. As you can see, there does not appear to be any air infiltration and the thermal bridge is limited to the metal only.

Bx1 Average	17,9 °C
Bx1 Maximum	18,2 °C
Bx1 Minimum	17,4 °C

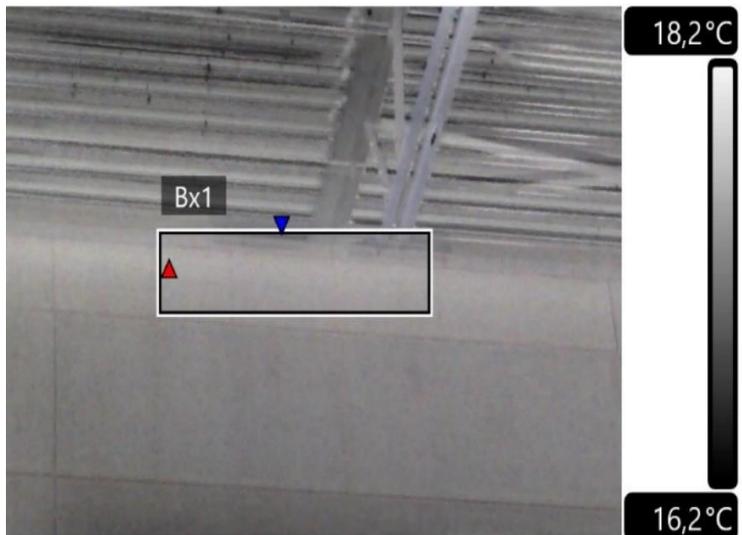
There did not appear to be any insulation loss at the junction between the facade and the roof of the building.

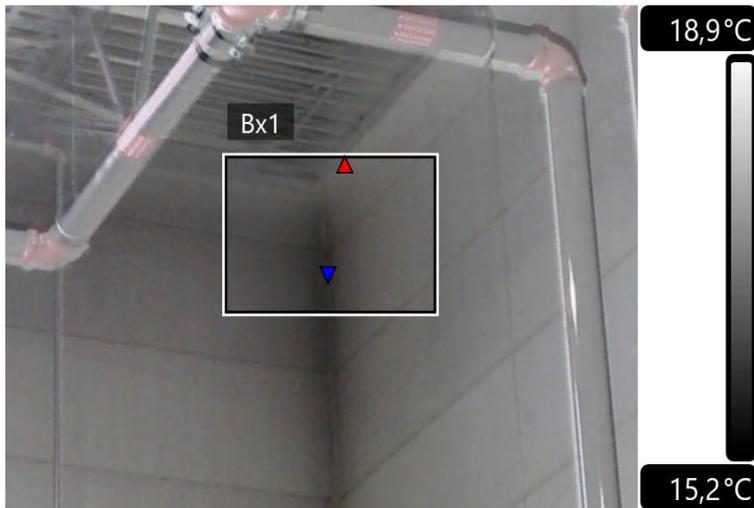
Bx1 Average	16,3 °C
Bx1 Maximum	17,1 °C
Bx1 Minimum	15,0 °C

Here is a triple corner (junction between 2 facades and junction with the roof) we can see that there does not seem to be any thermal losses at this level. It is quite rare in conventional construction to have corners without losses unlike block construction as illustrated.
