Inspection Report

Building Thermography

Rapid Bloc: Block on block compare to Modular

Date : 2025-03-03

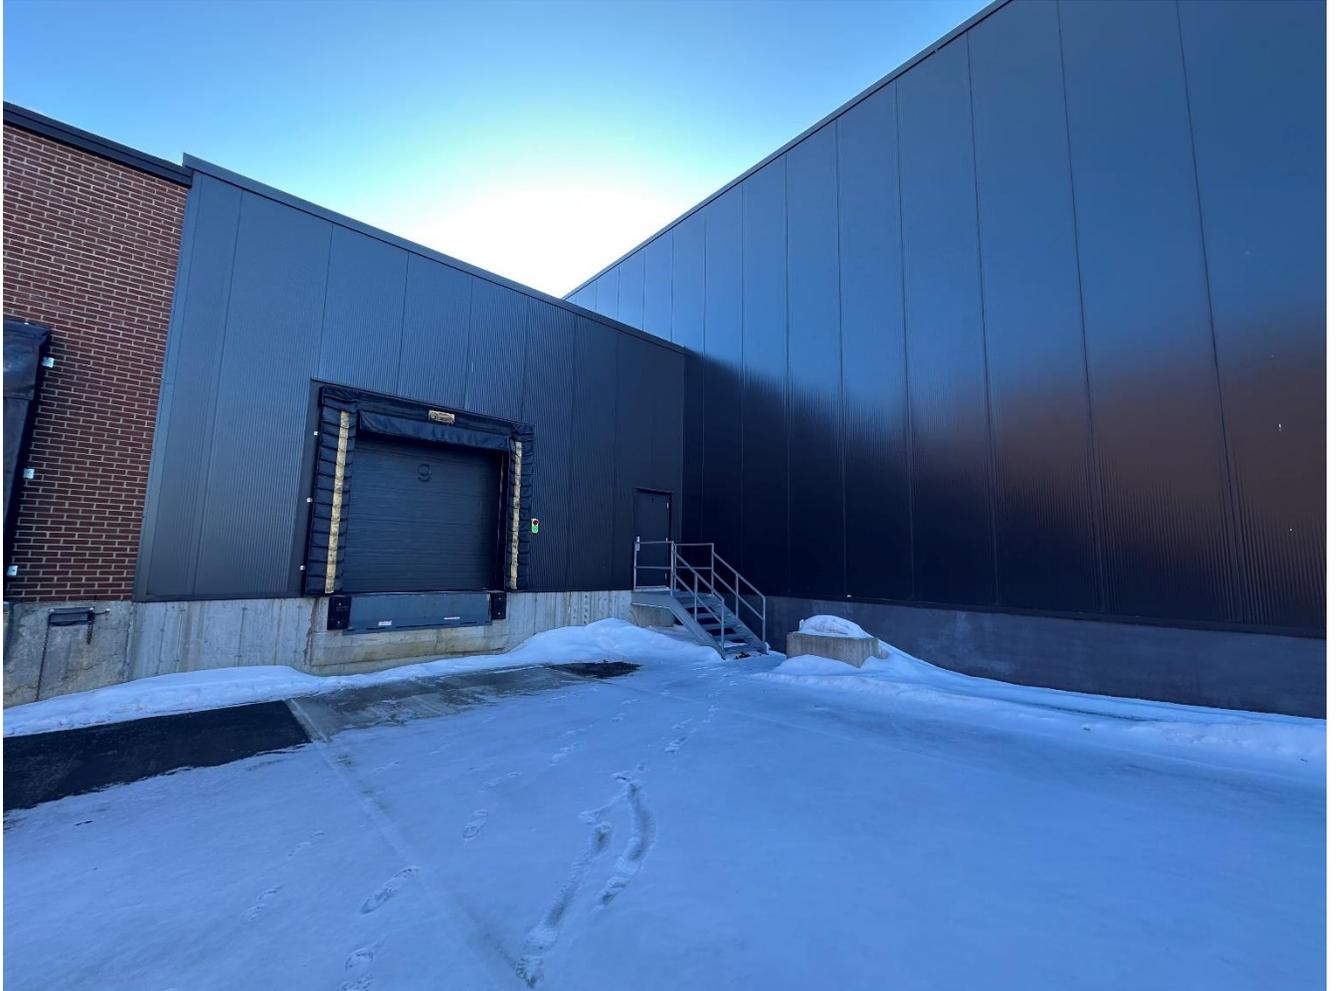
Exterior Modular Insulating Panels:

Modular Insulating Panels: The panels appeared to be well insulated and fairly airtight overall. One panel facade did not show any anomalies or loss of insulation/watertightness when joined end-to-end with other panels. The weak points observed were mainly at the junctions with other components (foundation, roof, door frame, etc.) or with other facades of different materials (such as the brick wall you will see below). There were several losses of airtightness/insulation in these cases. Note that modular insulating panels are installed on the surface of a steel structure that remains visible on the inside, which can present anomalies similar to the weak points observed with thermal imaging on a conventional construction (several possibilities of thermal bridges, air infiltration, etc.). You will be able to see a thermal bridge and air infiltration at the bottom of the inspected facades where the panel meets the foundation. There was also a lot of air infiltration near the doors. Some corners also showed slight thermal loss. The greatest air infiltration was found at a junction with a brick wall. It appeared as if the junction between the brick and panel facades was not sealed/insulated perfectly. In terms of insulation performance alone, the panels were better than conventional ones, but slightly worse than the blocks.

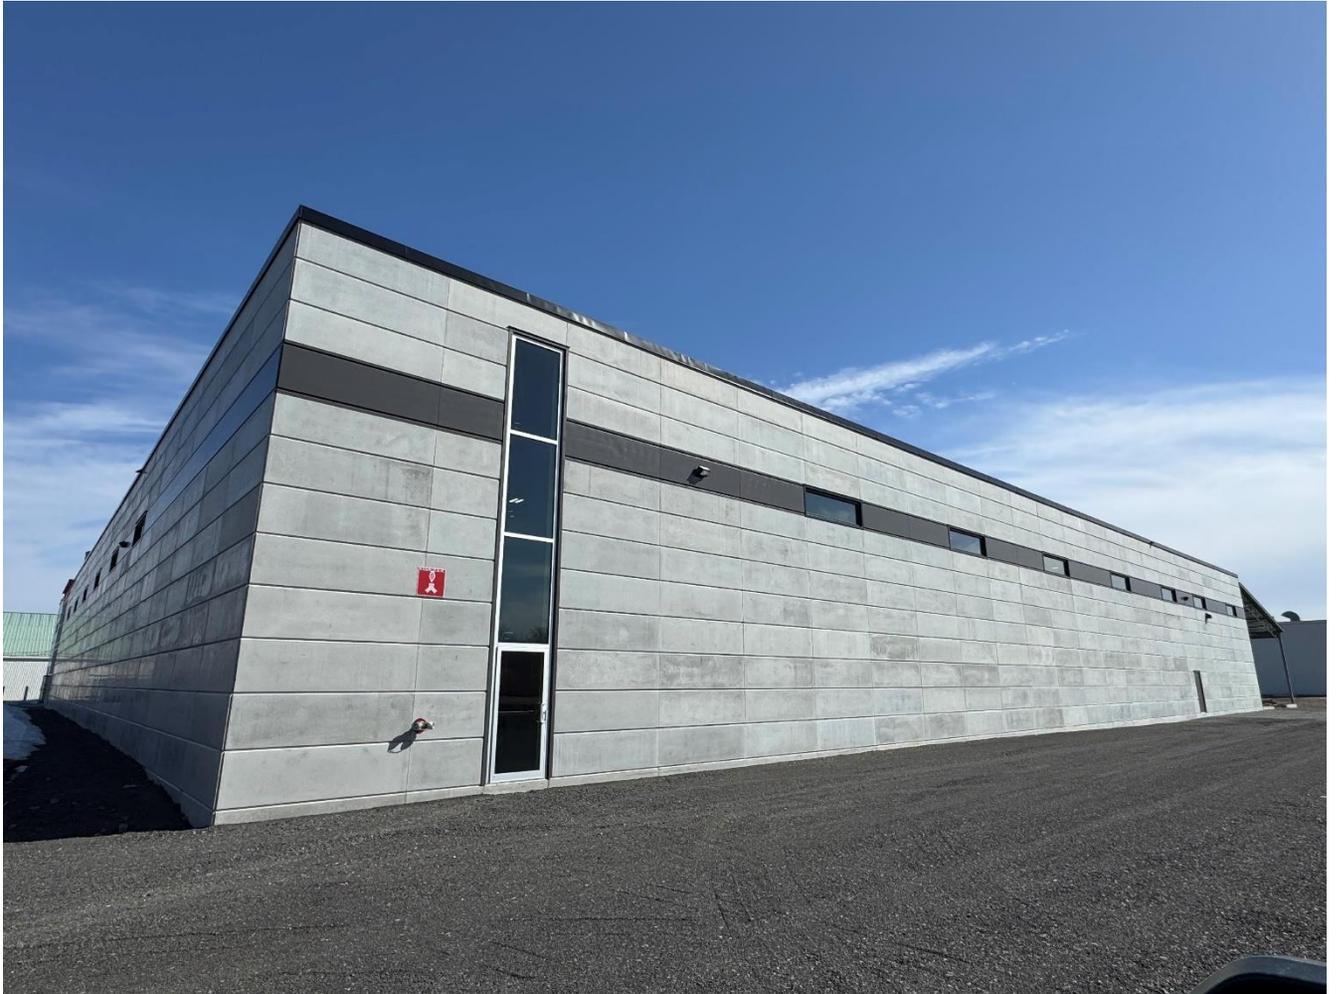
Exterior Rapid Bloc - Blocks on blocks:

Rapid Bloc (block on block): The block on block construction method (using 1 or 2 rows of blocks as foundation) is the most waterproof and efficient method observed during this thermographic inspection day. This method avoided losses of waterproofing and insulation and helped to greatly reduce the effect of thermal bridging with the outside temperature. This construction method is the best solution according to our thermal imaging observations in terms of thermal / energy efficiency. Building the foundation in blocks greatly reduces or even eliminates in many cases losses of waterproofing and thermal bridges. Therefore, the floor of the building and the lower section of the facade remain warmer, which should considerably increase the overall energy efficiency of the building and reduce heating costs. In addition, the thickness of the blocks seems to help to further cut thermal bridges and air infiltration due to the fenestration. The coolest points observed on a block facade were the windows (which is normal since they are less well insulated than the blocks, in addition to the fact that the metal frame conducts more temperature (thermal bridge)). The thermal bridge around the doors and windows and the air did not infiltrate as much and not in as large a volume as the other construction solutions observed. The blocks did not present thermal losses with the roof junctions, corners or other.
